AUTHOR	APPLICATION NOTE	DATE AND REVISION
ZENNARO ALBERTO	UPDATE PCO APPLICATION VIA PCOWEB	19/06/2007 - 1.0 DRAFT

2. Update pCO Application via pCOWeb

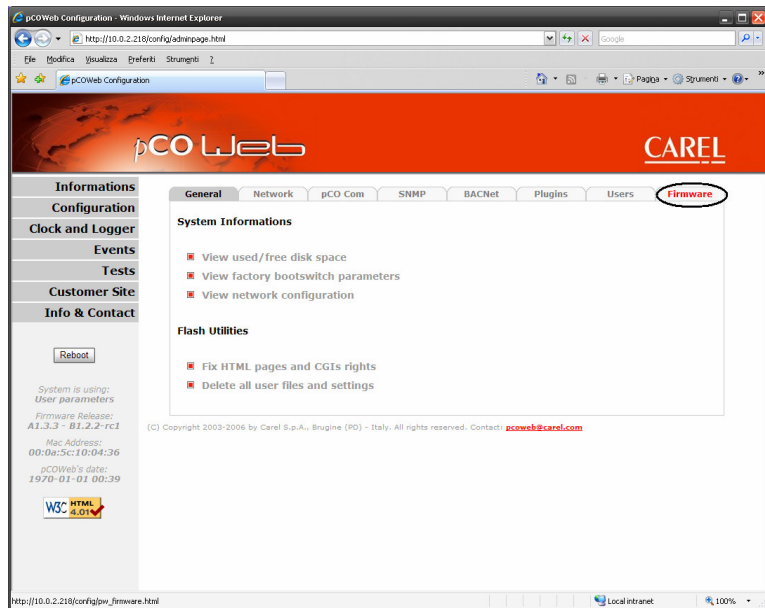
1. Connect to the card, as in section 3 of the pCOWeb manual.
2. Copy the application's files (.blb, .bin, .iup...) to the card via ftp to the special folder used `/usr/local/root/flash/http/pCO_Application/`, refer to the section 4.2 of the manual for the connection to the ftp server. It occurs that after the connection you are not able to see the folder "pCO_Application", it depends on the ftp browser, you can write it directly in the address bar.
3. Keeping the ftp browser open, connect to the card using a web browser (Internet explorer, Mozilla Firefox, Safari...), and go to the administration pages, then press "Configuration" on the left bar; after that select the tab "Firmware":

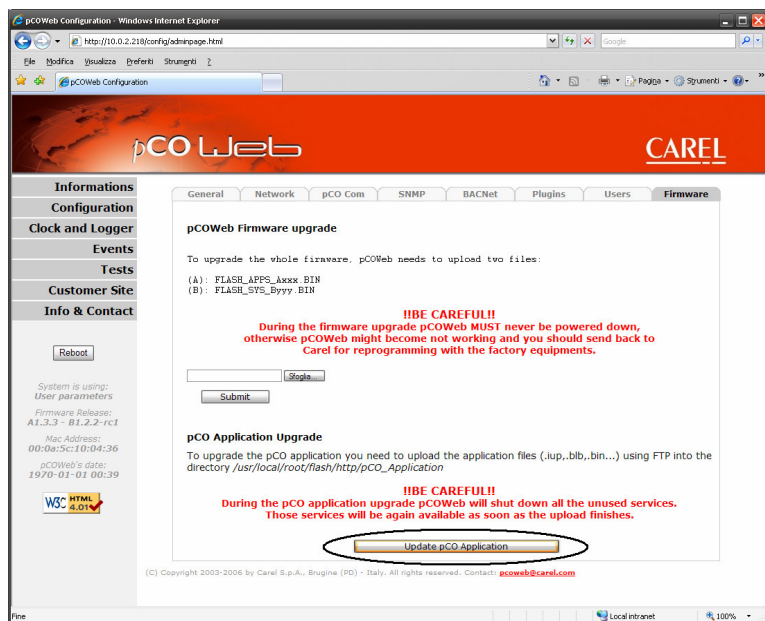
4. Now press the button "Update pCO Application":

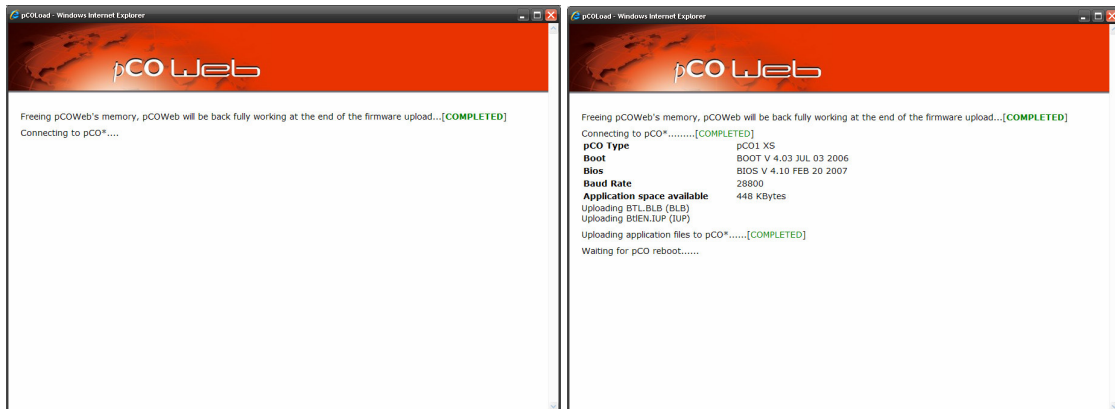
6. In the same window will appear a report of the card actions:

7. While the card is updating the pCO's application, the status led of the card blinks "green-red-off".
